# Appendix A

## **Terminal Introduction**

### **AIRPORT MASTER PLAN UPDATE**

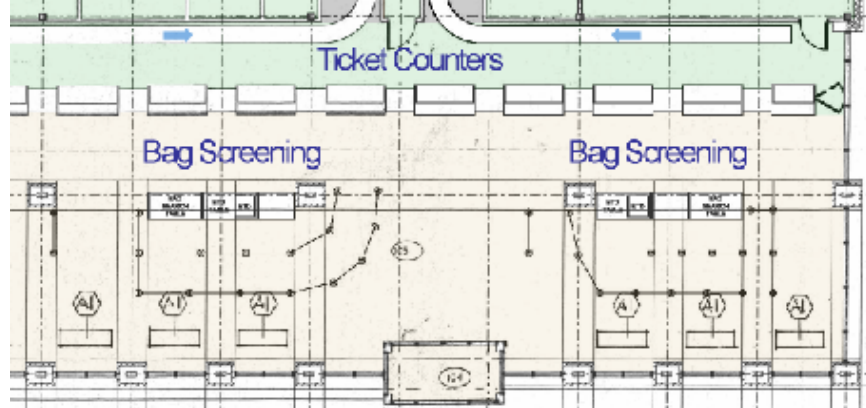
**Partial Fig. 1 - Existing Ticketing and Bag Screen Queuing**

The ticketing lobby was observed to be adequately illuminated, sufficient in floor area for processing the peak hour demand of passengers, based on original design. However, like many terminals since 9/11, the ticketing lobby now accommodates the passenger queuing space for ticketing as well as the TSA's explosive trace detection (ETD) processing stations. These ETD stations reduce the available queuing space for passengers waiting for ticketing, which was not designed for this activity. During the terminal survey, the two airlines (US Airways Express and Delta Connection), expressed concern over TSA's current methodology in screening passengers through the ETD process. Currently, passengers queue in between TSA ETD stations, which adds confusion as to where the ticketing line starts and

stops. Passengers initially queue, and then proceed through the ticketing process. Once ticketed, passengers are requested to proceed with their baggage in a reverse direction back through the queue to the ETD stations. A second queue in the same area as the ticketing queue is formed for ETD screening. The passenger then proceeds through the ETD screening and their bags are returned back to the ticket counter for loading onto the outbound conveyer. The back and forth movement is disruptive and confusing to the passengers. The airlines have requested a less confusing process to be developed.

Alternative solutions to this process include: relocating the TSA to the front (adjacent to the ticket counter), potentially placing the ETD process behind the ticket counter (**Figure 4**), or conducting the ETD screening or inspection by other equipment types in the baggage make-up area (**Figure 5**). The airlines reported that they do not like the idea of sharing space behind the ticket counter with the TSA.

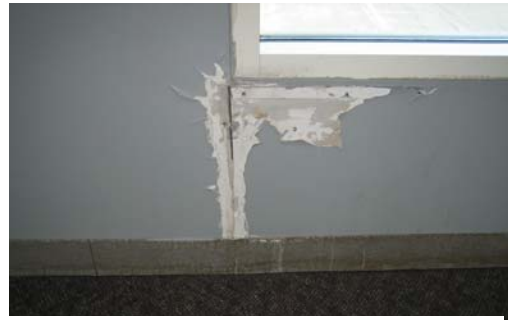
Damage is evident below the edges of the window openings at both the upper and lower holdrooms. The drywall is cracked and appears to have been repaired repeatedly and continues to crack, which is possibly due to condensation. The joint between the exterior window sill and wall has been recaulked. The wall base on the upper level is in poor condition. The base is discolored and spider cracks are visible throughout. The base at the lower level holdroom is in much better condition and may have been replaced at some point.

**Damage at Holdroom Window Sills**

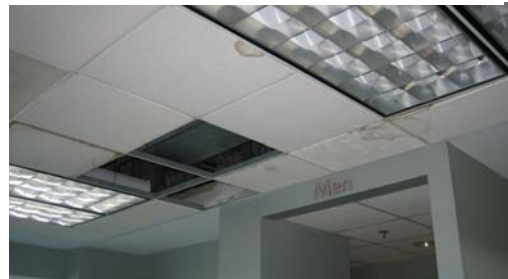
The overall condition of the acoustical tile ceiling in the holdrooms is good, other than a couple of areas. The ceiling tiles are not in as good condition at the back portion of the lower holdroom by the elevator and employee access door. Water stains have formed on the acoustical ceiling tile outside of the Men's restroom on the upper level below HVAC unit AC-5. Roof and window weather-proofing should be inspected in greater detail to determine the cause of the water infiltration.

**Water Damage at Holdroom Ceiling**

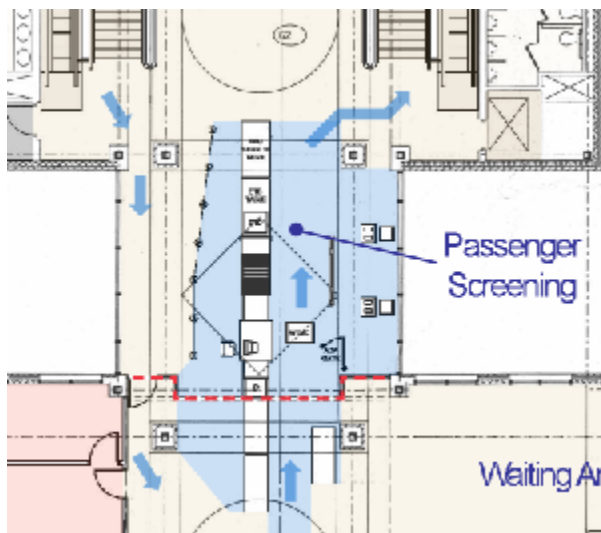
**Partial Fig. 1 – Existing Passenger Screening & Deplaning Corridor**

The original design of the terminal allowed for the entire width of the connecting bridge between the terminal and the holdrooms to be utilized for enplaning and deplaning passengers. Current TSA security operation occupies the majority of the bridge for passenger screening, which impacts the available circulation space for deplaning passengers. After deplaning and ascending up the escalator, the passengers encounter a wall and have to turn immediately to the left to enter a narrow single-file passageway to reach the non-secure side of the terminal. This exit flow should be improved to be more straightforward.

An option for improving the flow for deplaning passengers would be a 200 s.f. (approx. 9' x 22') expansion to the side of the connecting bridge and a 1,000 s.f. (approx. 29' x 35') expansion to the

administration suite (**Figure 3**). This modest expansion would provide a logical deplaning corridor, increase passenger flow and will provide additional space for passenger screening. Although it would be necessary to displace a portion of the airport administration suite to accommodate this expansion, the admin. Expansion would include the displaced area. To address the displaced administration area the conference area within the administration suite would be divided in half, providing two offices and a 950 s.f. (approx. 28' x 34') expansion to the end of the suite to provide an adequately sized conference room. There is not a specific time frame associated with implementing this improvement; it would be up to the airport to determine based on the availability of funds.

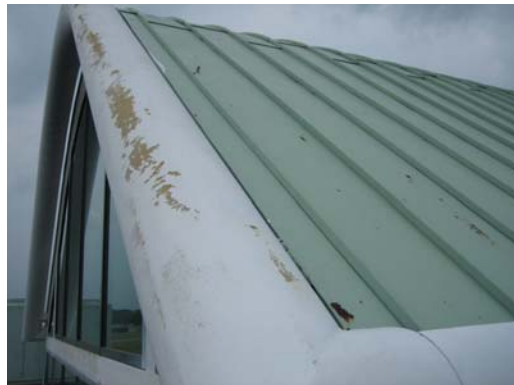
The standing seam metal roof and surrounding trim is in need of repair. The white perimeter of the roof is in need of new paint and numerous rust spots are visible throughout the metal roof panels. Funds should be budgeted for repair or replacement. No roof leaks were evident relative to the metal roof panels at this time. HNTB's recommendation is to have a roof professional evaluate the panels to determine whether the rust spots could be repaired and when a new roof would likely be required.

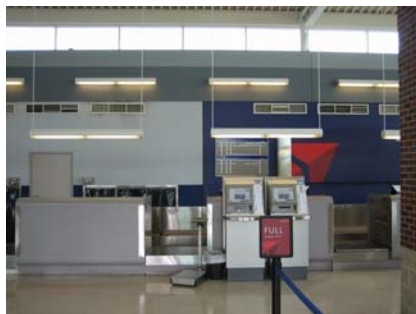
**Ticket Counters**

form appearance. The ticket queuing area would be fine as it is if the bag screening could be relocated. The ticket counters are showing wear and the is damaged in areas. An updated ticket counter area, new ticket counters and moving the bag screening operation out of the ticket lobby would positively impact the passenger experience.
