# Appendix A

## **Terminal Introduction**

### **AIRPORT MASTER PLAN UPDATE**

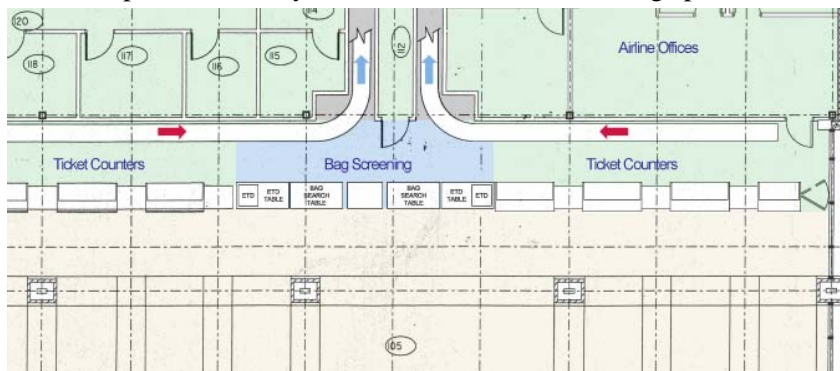
**Partial Fig. 4 - Upper Level Baggage Screening Option**

Alternative solutions to this process include: relocating the TSA to the front (adjacent to the ticket counter), potentially placing the ETD process behind the ticket counter (**Figure 4**), or conducting the ETD screening or inspection by other equipment types in the baggage make-up area (**Figure 5**). The airlines reported that they do not like the idea of sharing space behind the ticket counter with the TSA.

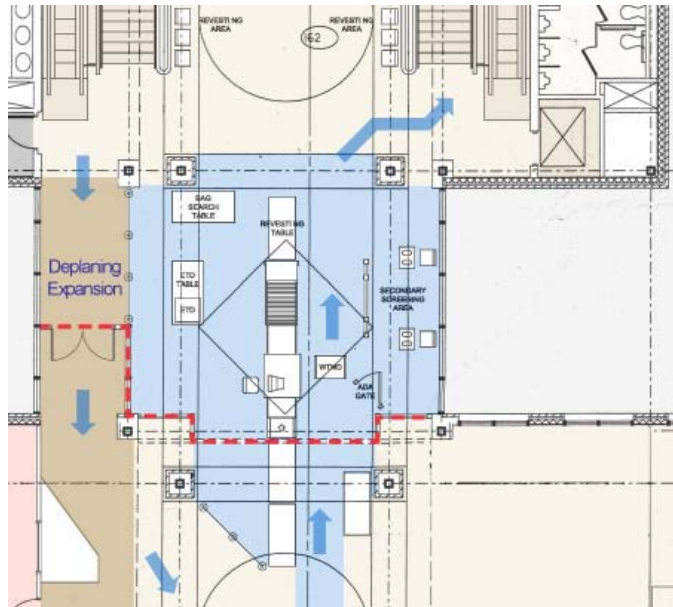
**Partial Fig. 3 – Deplaning Expansion**

An option for improving the flow for deplaning passengers would be a 200 s.f. (approx. 9' x 22') expansion to the side of the connecting bridge and a 1,000 s.f. (approx. 29' x 35') expansion to the

administration suite (**Figure 3**). This modest expansion would provide a logical deplaning corridor, increase passenger flow and will provide additional space for passenger screening. Although it would be necessary to displace a portion of the airport administration suite to accommodate this expansion, the admin. Expansion would include the displaced area. To address the displaced administration area the conference area within the administration suite would be divided in half, providing two offices and a 950 s.f. (approx. 28' x 34') expansion to the end of the suite to provide an adequately sized conference room. There is not a specific time frame associated with implementing this improvement; it would be up to the airport to determine based on the availability of funds.

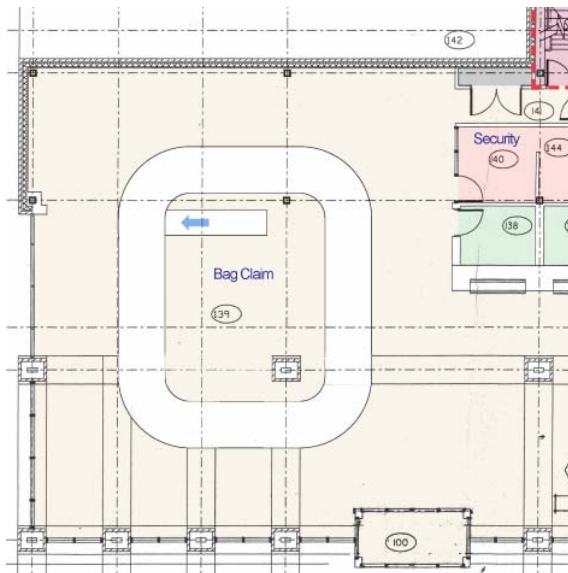
**Partial Fig. 6 - Bag Claim Expansion**

All aircraft are ground-loaded regional aircraft and many passengers claim their gate-checked baggage next to the aircraft on the apron before entering the building. Delivery time to the bag claim device is very short. The baggage claim area appears adequate for the current peak hour passenger demand. The

projected peak hour deplanement notes an increase through 2026 (**Table 25** in the forecast chapter). The number of passengers checking bags varies from 50-75%. For evaluating the bag claim area, it is assumed that 65% of deplaning passenger will check bags at the peak hour. This is a conservative figure, as the current bag fees may result in fewer checked bags. Per the forecast, the bag claim device is anticipated be 15% over capacity by 2011. If the bag claim device is expanded (**Figure 6**), it will have sufficient capacity through 2026. Another scenario that may result in an increase in bag claim device capacity is if narrow body service were to serve LYH. The expansion shown in Figure 6 utilizes available open space, would not negatively impact the ready/return lot adjacent to the terminal and would not require a terminal expansion. One concession that would need to be made is the loss of the display area in that part of the terminal.

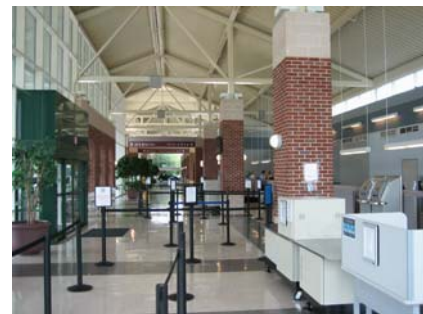
**Ticket Lobby**

form appearance. The ticket queuing area would be fine as it is if the bag screening could be relocated. The ticket counters are showing wear and the is damaged in areas. An updated ticket counter area, new ticket counters and moving the bag screening operation out of the ticket lobby would positively impact the passenger experience.
